DEAERATING HEATER PROBLEM CHART

PEMCO DESIGN SERVICE
 TEL. 516-735-6629
 FAX: 516-735-8153
DEAERATING HEATER REPLACEMENT PARTS

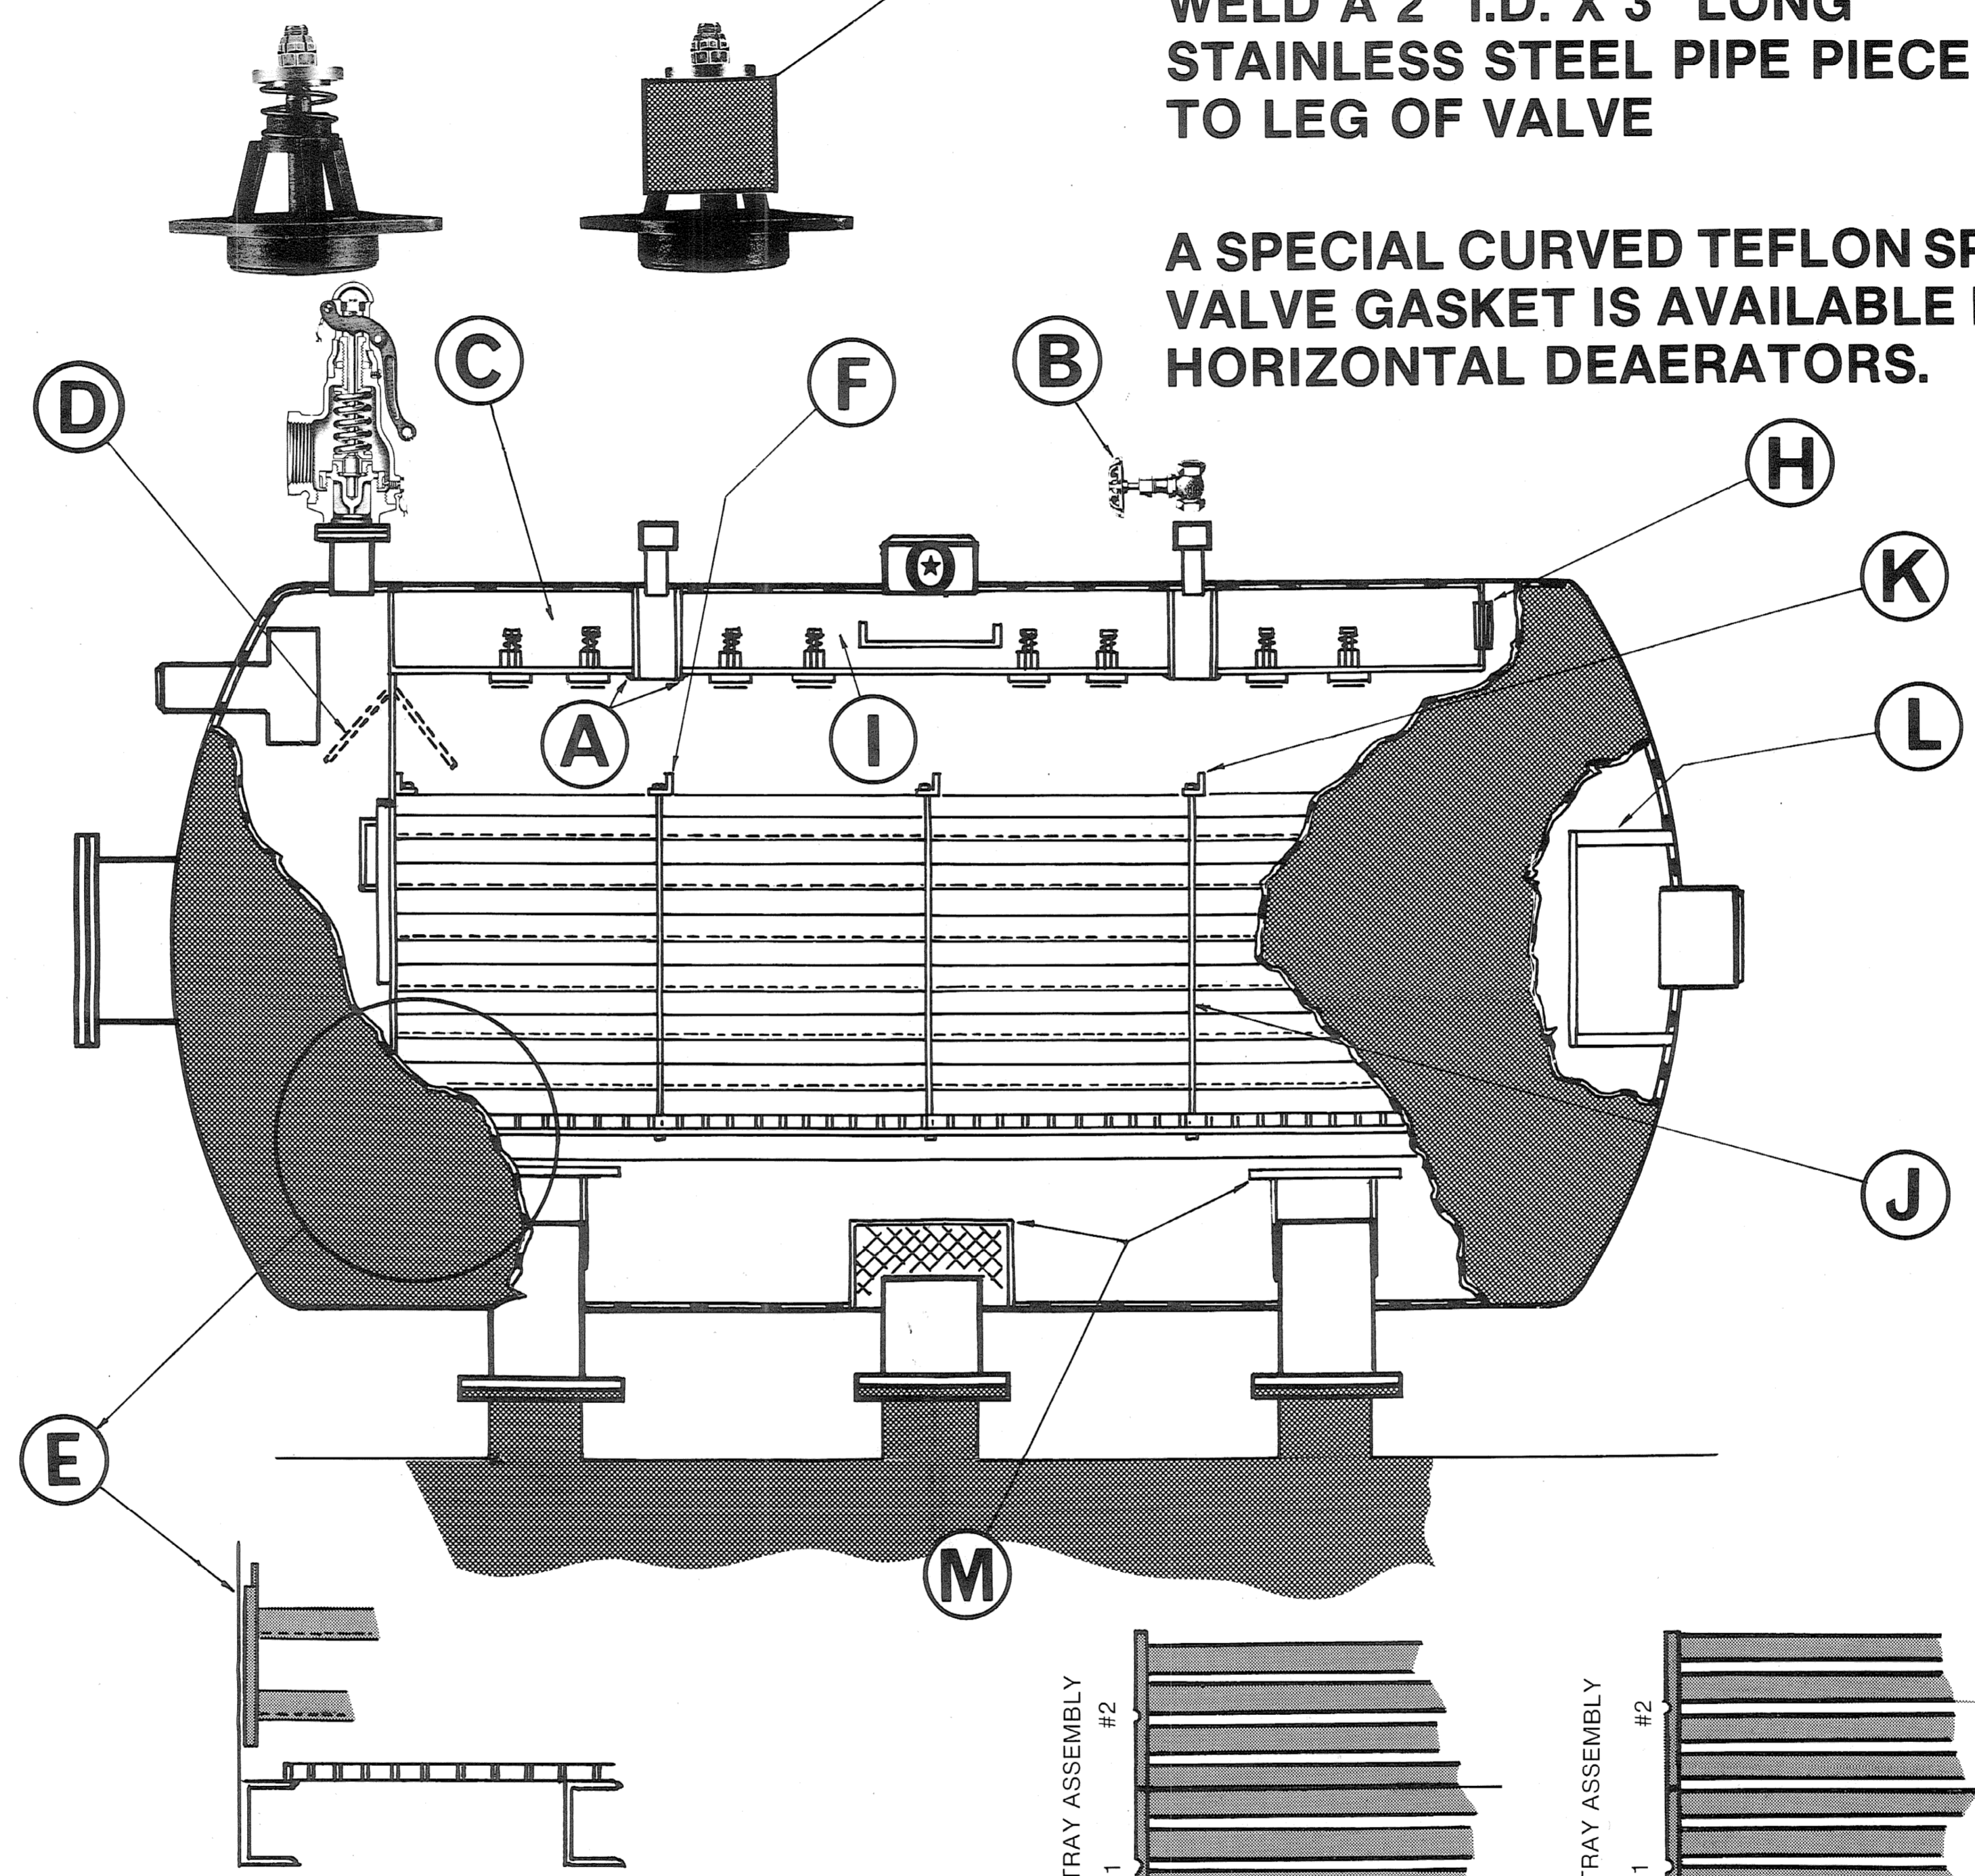
- (A) WATER DISCHARGING (SPEWING) FROM VENT LINE**
 1. INSPECT WELDS AROUND INTERNAL VENT CAPS OR VENT PIPE
 2. SPRAY VALVES LOCATED TOO CLOSE TO VENT PIPE (STEAM DRAWS UP WATER FROM SPRAY VALVE ANGLE THRU VENT)

- (B) DRILLED ORIFICE IN VALVE DISC**
 1. 1/8" HOLE IS A SAFETY FEATURE TO PROTECT DEAERATOR IF VENT VALVES ARE ACCIDENTLY CLOSED DUE TO MAINTENANCE
 2. ORIFICE IS USED WHEN ALL FLOWS REMAIN CONSISTANT.

- (C) NOISE INSIDE DEAERATOR SPRAY VALVE COMPARTMENT.**
 1. SPRAY VALVE SPRINGS ARE DAMAGED, SNAPPED, OR HANGING
 2. OVERTIGHTENED SPRINGS (LOOSE, SPRING TENSION) CAUSES BANGING IN WATER BOX

3. BROKEN SLATS ON TRAY ASSEMBLIES.
- (D) PRESSURE EQUALIZING DOOR ON TRAY ENCLOSURE.** VERIFY HINGE IS FREE FROM BINDING OR DAMAGE TO CORNERS OF ENCLOSURE.

- (E) TRAY UPSETS**
 1. TRAY SUPPORT GRATING NOT BUTTED AGAINST FRONT OF ENCLOSURE. HEAD OF TRAY ASSEMBLY WILL FALL BETWEEN GRATING & ENCLOSURE WALL (ADD FLAT BAR TO FILL GAP)

- (F) TRAY HOLD DOWN ANGLES OR TROUGHS MUST BE FIRMLY POSITIONED ON TOP OF TRAYS TO PREVENT MOVEMENT OR TRAY UPSETTING**

- (H) SPRAY VALVE INSPECTION PLUG VERIFY PLUG IS INSTALLED. (4")**
- (I) SPRAY VALVE SPRINGS CONSISTANTLY DAMAGED IN THIS AREA. (WATER INLET) WELD A 2" I.D. X 3" LONG STAINLESS STEEL PIPE PIECE TO LEG OF VALVE**

- (L) CHECK ALL INTERNAL BAFFLES FOR WELD DAMAGE**
- (M) INSPECT OUTLET SCREEN AND EQUALIZING SHIELDS FOR DEBRIS OR DAMAGE.**

- (G) INSTALL TRAY ASSEMBLIES CORRECTLY. TRAYS MUST BE INSTALLED WITH LOCKING TABS FACING UP AND MUST BE POSITIONED SO EACH TRAY HAS A SPACE AS INDICATED**

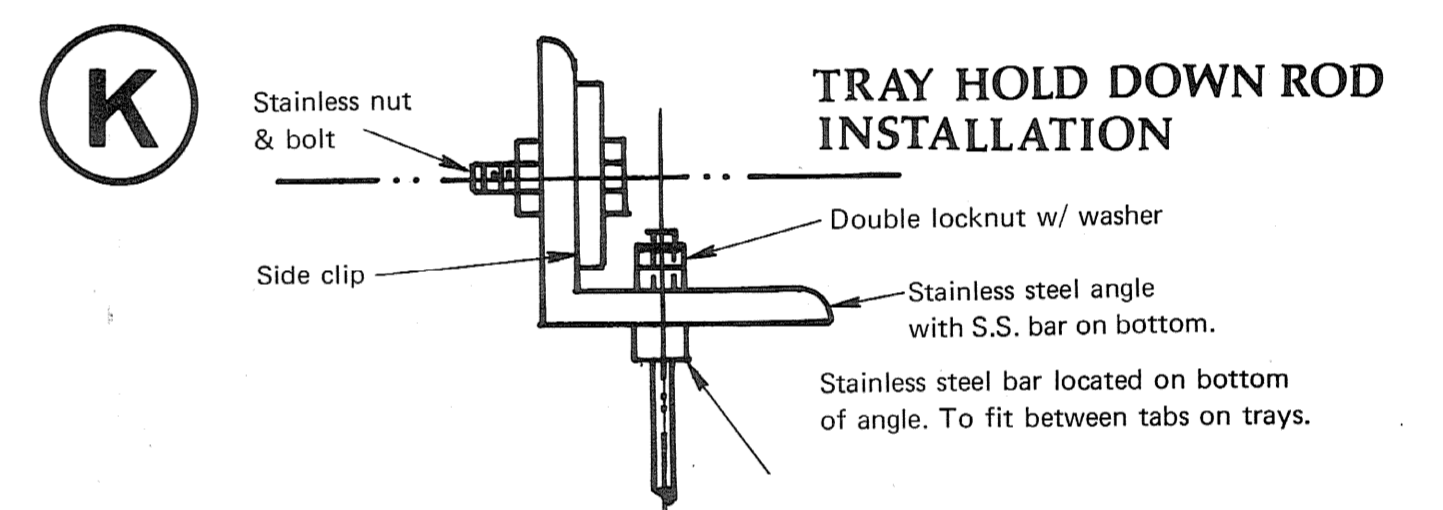
- (J) INSPECT TRAY HOLD DOWN RODS. VERIFY RODS ARE IN PLACE AND POSITIONED THRU HOLD DOWN ANGLES. "DO NOT USE NYLON INSERTS ON LOCKNUTS)**

DO NOT USE AIR GUN WHEN REMOVING OR INSTALLING SPRAY VALVE LOCKNUTS DO NOT REUSE LOCKNUTS
